Confidential Property Inspection Report

PROPERTY INSPECTION REPORT

Concerning: 777 Myaquarium, Somewhere TX
(Address or Other Identification of Inspected Property)

By: Will Misegades TREC#10465 4/27/2010
(Name and License Number of Inspector) (Date)

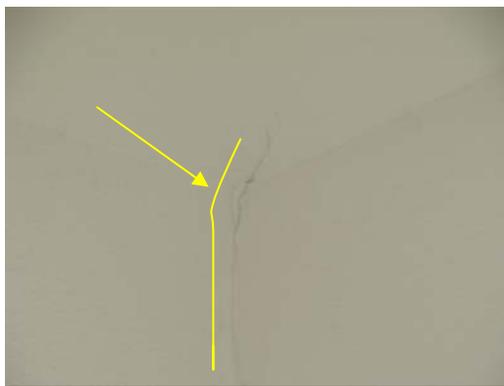
Evidence of a slight differential deflection was noted on inside structure. Master bedroom has a crack in the South-East corner wall. **In my opinion the deflection or racking does not appear to affect the functionality or usability of the foundation. An effort should be made to maintain an even moisture content in the soils surrounding the foundation.** If there are any concerns, I recommend having a certified & licensed structural and / or foundational specialist inspect structure.

The structure has attaching slabs “expansion joints”. *This is a location for wood destroying insects (termites) to enter the home. Home owner needs to perform frequent inspections of these areas.*

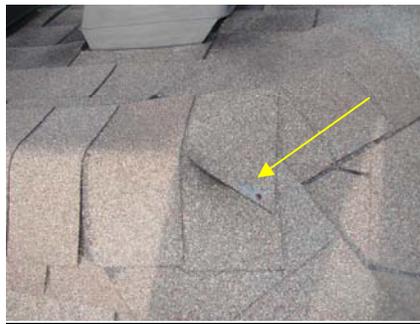
Exposed nail heads at either the vent & roof flashing or at the composition shingles can allow water to penetrate past the roof covering given enough time. *As the exposed portion of the nail rusts, more space will become available between the nail and the roofing material for water to penetrate. This condition can usually be remedied by sealing or caulking affected areas*

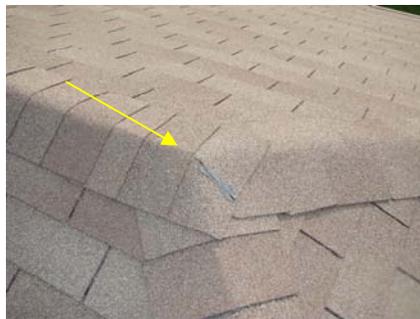
Ridge shingle has sealant, I recommend monitoring and re-seal as needed to prevent water penetration

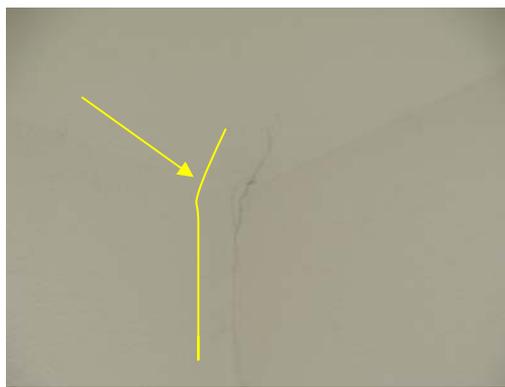
Common cracks up to 1/8" were noted in the interior gypsum wallboard. *Cracks near the interior windows and doors are usually indications that there is some degree of movement occurring in the structure. (in any structure some degree of movement is normal and should not be of concern) the severity of the cracks can be an indication of the amount of movement in a structure.*

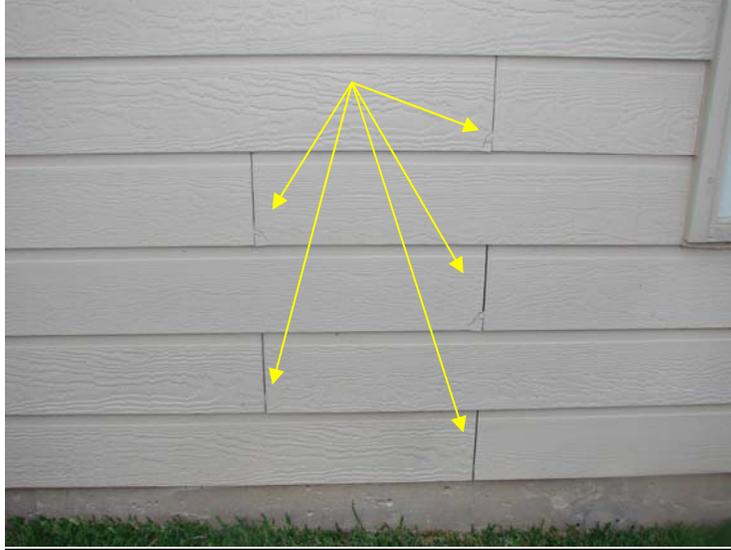
Siding joints on the exterior are not caulked and some corners are broken. *These joints and corners should be caulked immediately as water could penetrate and damage the structure.*

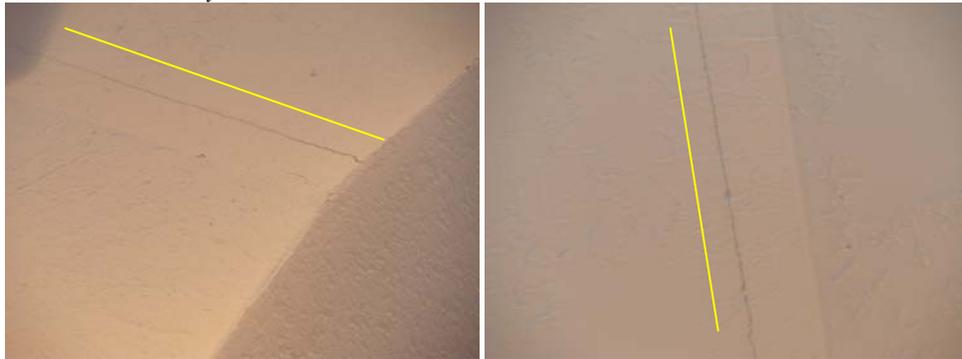
Common cracks up to 1/8" were noted in multiple areas of the ceiling. *Caulking and then repainting is the common remedy.*

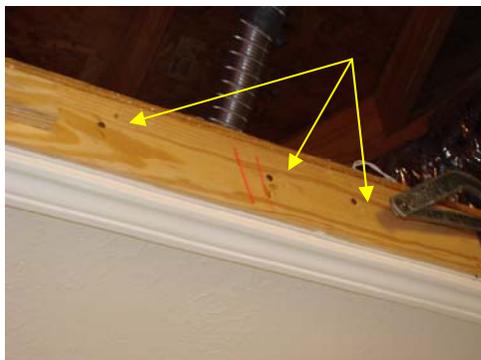
Attic access door frame not properly secured to framing: *Recommend installing lag screws*

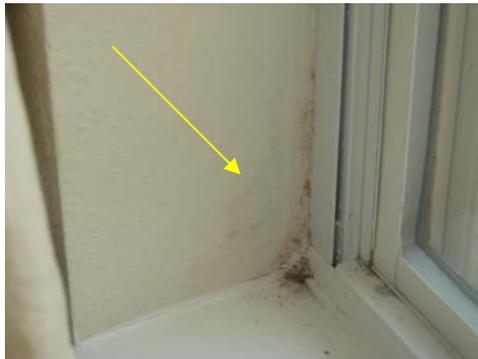
Evidence of moisture, stain or foreign substance was observed on various windowsills and casings.

Windows are a common source of water penetration. Leaking at the window can cause hidden or concealed damage. Caulking or sealing the exterior window frames can sometimes remedy this condition. All damaged elements should be repaired or replaced.

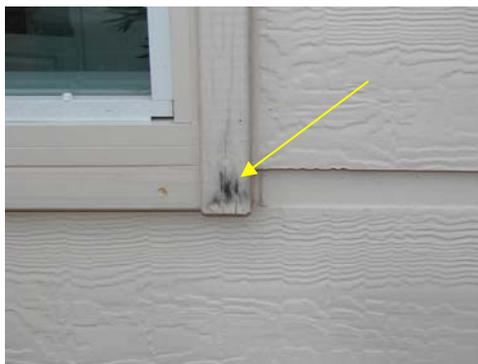
Trim around windows on outside have signs of culture growing around nail entrance. Recommend cleaning, caulking and painting to prevent water penetration around window.

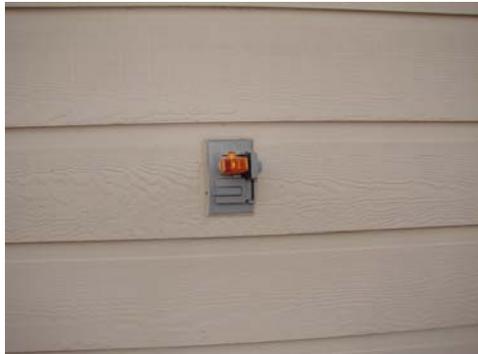
It is recommended to have all Exterior outlets protected with a bubble cover.

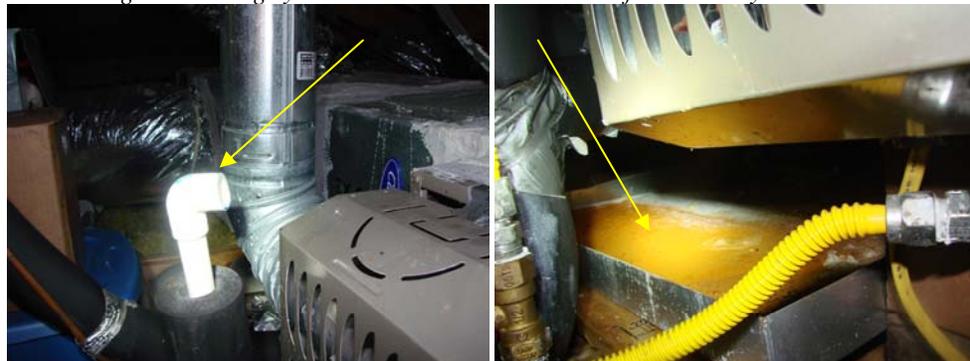
Unit did not operate within the allowable capacity tolerance (14°-21°).

Rust was present in the secondary safety pan under the evaporative coil indicating previous leaks.

A PVC pipe connected to the AC unit was dispensing cold air into the attic

A technician should evaluate, repair as needed and service the entire H.V.A.C. system as the air conditioning and heating system share common elements of the same system

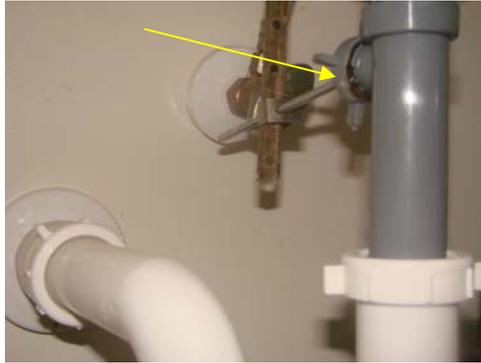
A leak was detected in drain stop system under rights side master sink. *These leaks can promote water penetration to the structure. Concealed damage is a possibility. The drain stop should be serviced and any damaged components replaced or repaired.*

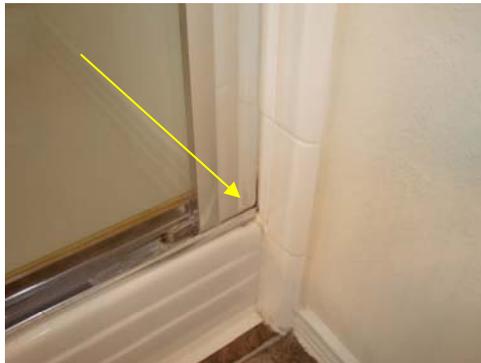
Master shower door from had a previous leak. Recommend re-caulking and monitoring

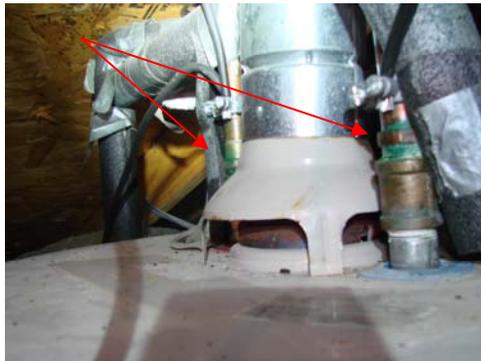
Signs of corrosion on cold and hot water pipes on top of water heater. Recommend having a licensed plumber evaluate and proceed as needed

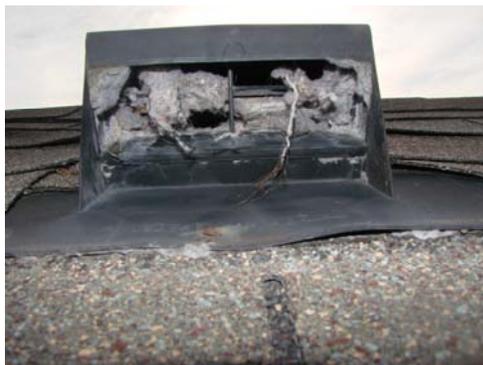
Dryer vent on the roof requires cleaning
